# **Investigation of Gas Well Blowout Brazos Area Block A-23 May 30, 1990**

**Gulf of Mexico  
Offshore Texas**

**U.S. Department of the Interior  
Minerals Management Service  
Gulf of Mexico OCS Regional Office**

**New Orleans  
December 1992**

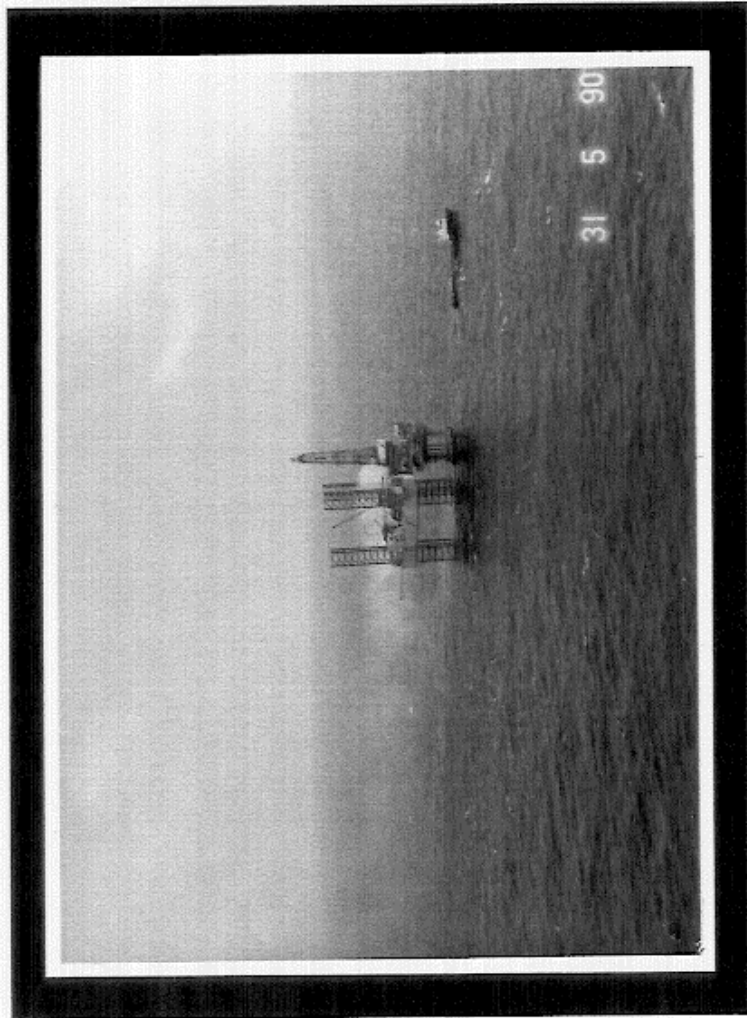
Aerial view of the blowout well.

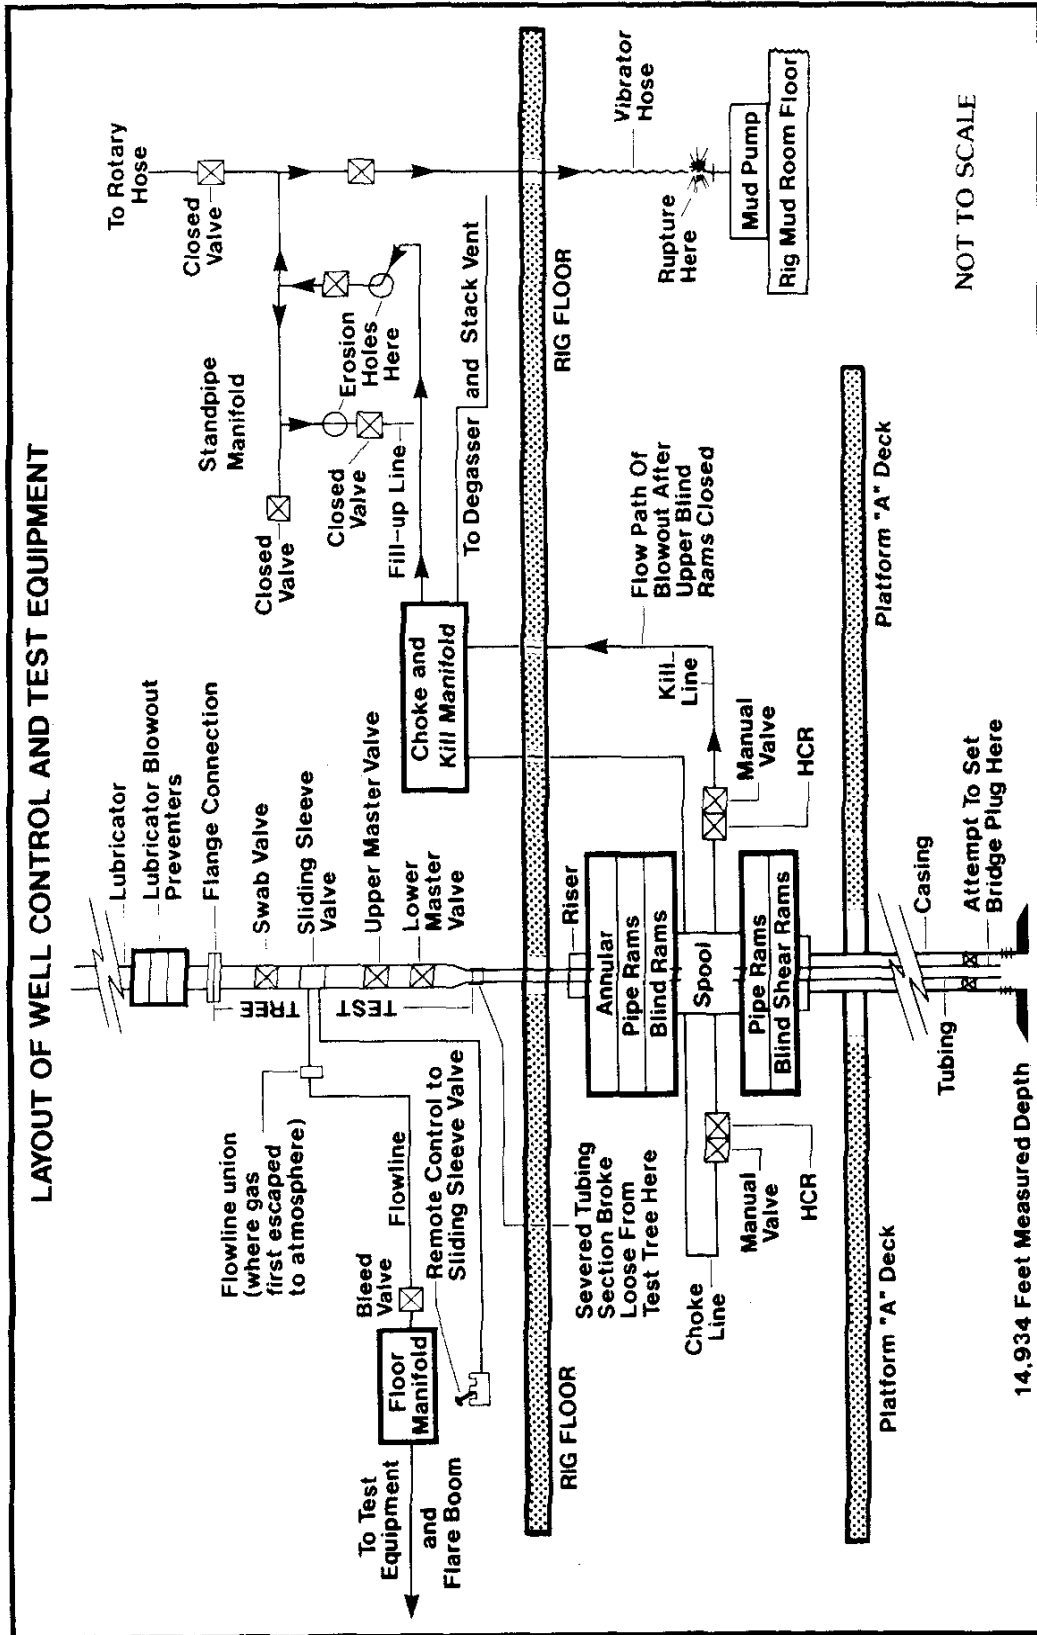
The sequence of events is as follows. Please refer to Attachment 3.

1. The shut-in surface well pressure of 9,200 psi inside the upper portion of the test tree and lubricator was being bled down to 800 psi when the pressure seal in the upper master valve in the test tree failed under the

8,400-psi pressure differential. The resultant surge of gas into the lubricator propelled wireline tools inside the lubricator against the top of the lubricator. The tool string broke near its top, allowing the tools to fall onto the closed upper master valve in the test tree.

2. The jarring effect of the upward and downward blows by the wireline tools to the test tree and lubricator assembly was transferred to a *flowline union located near the test tree outlet. As a result, the union began to leak.* The rig floor area rapidly became engulfed with escaping gas.

3. The manual bleed valve on the flowline at the floor manifold was closed, and the remote control to the sliding sleeve valve at the test tree outlet was activated to close the valve, but flow out of the union continued. There is inconclusive evidence as to whether the sleeve valve failed to close or the source of continued flow was from the gas trapped under pressure in the 50 feet of 2-inch ID flowline between the test tree and the closed valve on the flowline at the floor manifold.

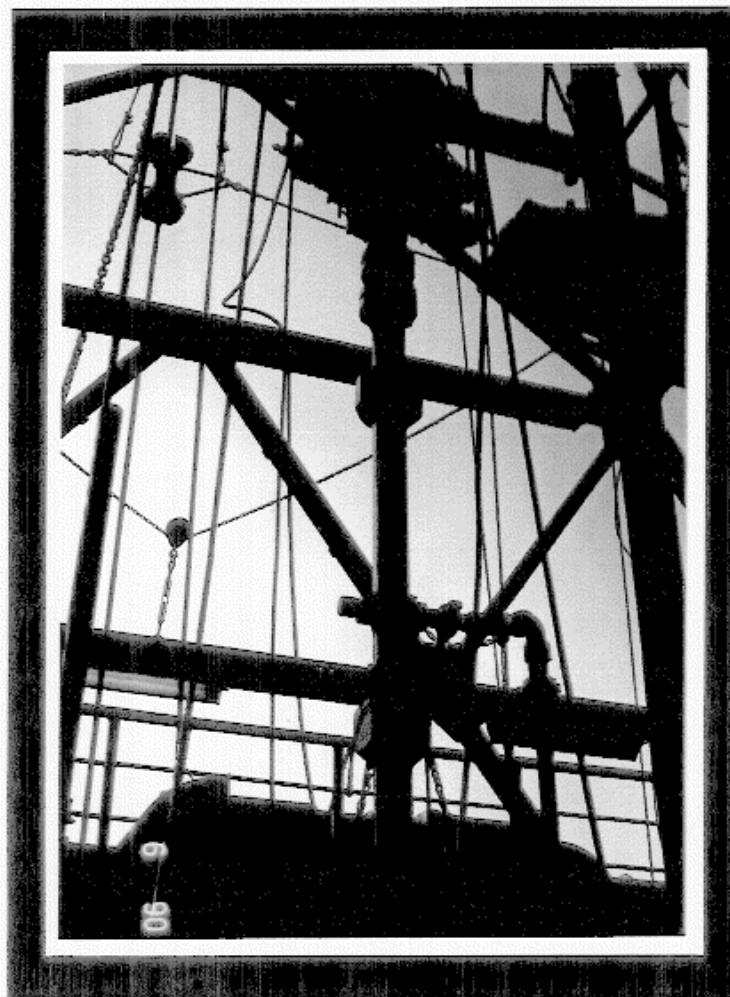
Subsequent tests on the test tree and its component valves by an independent testing laboratory showed that the valve cores and seals in the inlet and port areas of both master valves were damaged and would hold no pressure. The damage is attributable to erosive flow through the valves while in a closed position. Before the shipment of the test tree to the laboratory, numerous CIBP fragments, including the slips, were found loose inside the test tree and were removed. All but the top part of the wireline tool string was found resting on the closed upper master valve in the test tree. Evidence suggests that when the master valve failed, the surge of gas into the lubricator propelled the tools against the top of the lubricator. The impact broke the tool string near its top, and the tool string fell approximately 46 feet onto the closed upper master valve in the test tree. The impact shattered the CIBP and delivered a jar to the test tree. The jar was transferred to a flow-line union through a direct, short, and rigid pipe connection between the test tree outlet and the union. The union then began to leak. In the laboratory, foreign material was found loose in the body of the upper master valve and in the outlet port of the remotely operated sleeve valve. The foreign material consisted of four irregularly shaped pieces of metal approximately 1/4-inch wide and ranging in length from 1/4 to 3/4 inches. Some of the pieces clearly showed striations on their surface, indicative of machining and of being CIBP fragments. There is no evidence that the foreign material interfered with the operation or pressure integrity of any valve at the time of the accident. Both the swab valve and the sliding sleeve valve in the test tree passed laboratory tests for operation and pressure integrity.

Test tree as seen above the rig floor after the blowout. Note the tie-down chains, bottom center.

1. If a well with a surface BOP stack and an anticipated surface pressure greater than 5,000 psi is to be production tested, consideration should be given to equipping the test tree assembly with (a) a surface-controlled, tubing-retrievable safety valve inside the test string below the BOP stack and (b) two or more master valves, a swab valve, and a remotely controlled actuator on at least one of the master valves.

2. When it becomes known that any master valve or other component in a test tree or related flow-control equipment is defective in function or pressure integrity, operations should be suspended and the well secured until system integrity is restored.

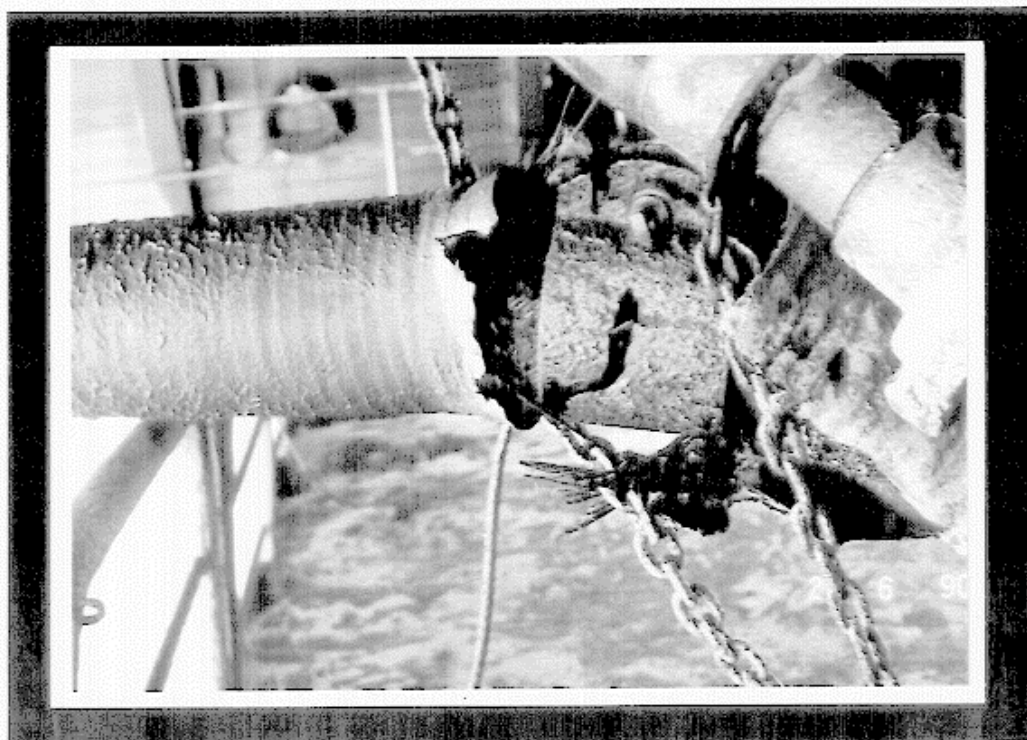
At approximately the same time the blind rams were closed, two more loud noises were heard. These noises were most likely the rig pump vibrator hose rupturing in stages below the rig floor. (See Attachment 5.) Well pressure, far in excess of 5,000 psi, reached the 5,000-psi RWP vibrator hose from the well because well pressure was communicated through the open HCR and manual valve on the kill-line side of the spool at the BOP stack, through the kill line, through a valve on the choke and kill manifold that was inadvertently left open, to and through the standpipe manifold, to and through the vibrator hose, and on to the rig mud pumps. The pressure safety valve (PSV) in the discharge line at the mud pump did not operate

at its set pressure of 4,200 psi. The PSV was subsequently found functional, indicating the hose ruptured at a pressure below 4,200 psi. With the rig area engulfed by escaping gas, orders were given to abandon the rig. All 51 persons aboard the facility were evacuated without injury. Before the rig was abandoned, two emergency power shutdown switches were activated, but both switches failed to function. Time did not allow rig personnel to activate the other emergency power shutdown switches on the rig, and the generator engines were left running. Subsequent inspection showed the cause of switch failure was broken glass in one switch and corrosion damage to the other. This gas well flowed uncontrolled into the atmosphere for 17½ hours with the generator engines running, but there was no fire or explosion. It took an additional 29 hours before the well was killed with mud.

Ruptured rig pump vibrator hose as seen from below the rig floor.

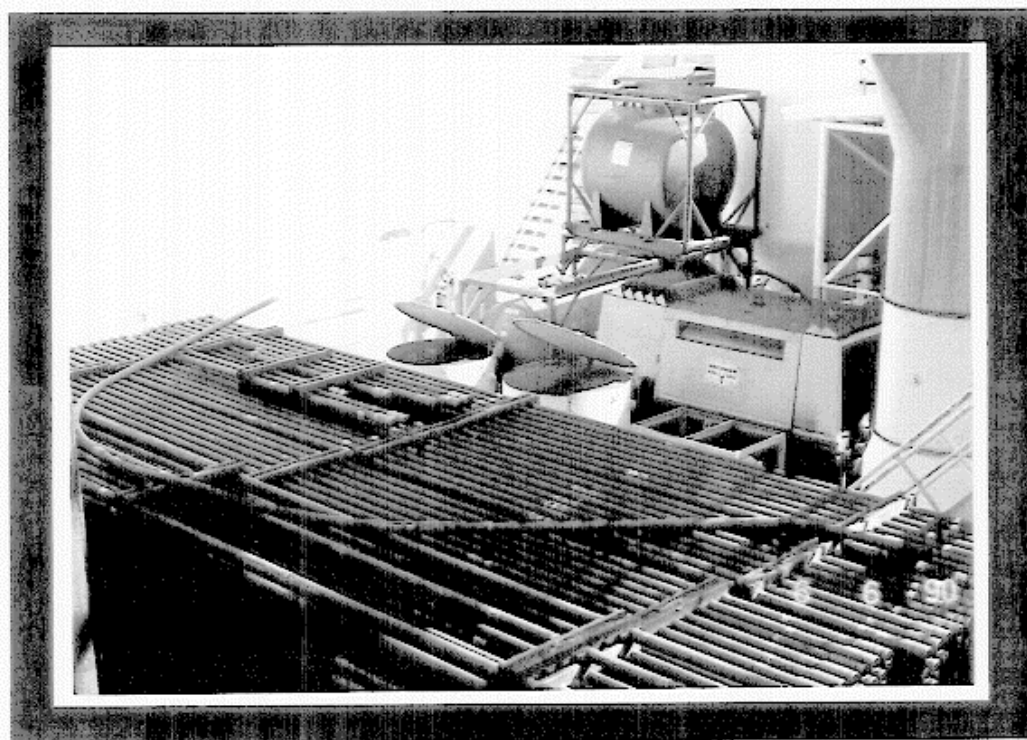
Subsequent investigation of the severed tubing showed that it had been crimped into an oval shape where sheared, with a small tooth-shaped nub of torn metal remaining at the place sheared. Inspection of the blind-shear rams after the incident showed a resilient seal on one ram was completely destroyed. Damaged areas of  $\frac{1}{8}$  to  $\frac{1}{4}$  inch in size, caused by erosive flow, were found on each side of the other ram.

rams. During the jacking up of the rig, the blind-shear rams failed. Well pressure and flow velocity blew the 38-foot long section of severed tubing out of the well through the rotary table and onto the rig floor. The well then flowed into the atmosphere out the top of the BOP stack.

38-foot length of severed 2 <sup>7</sup>/<sub>8</sub>-inch tubing as seen on the pipe racks after the blowout.
